**REPORT OF
STEAM RELEASE EVENT
EXTRACTION WELL EW-5
VISALIA STEAM REMEDIATION PROJECT**

Southern California Edison
Environmental Affairs Department

April 30, 1999

Preliminary analysis of the failure of well EW-5, Visalia Pole Yard, February 1, 1999

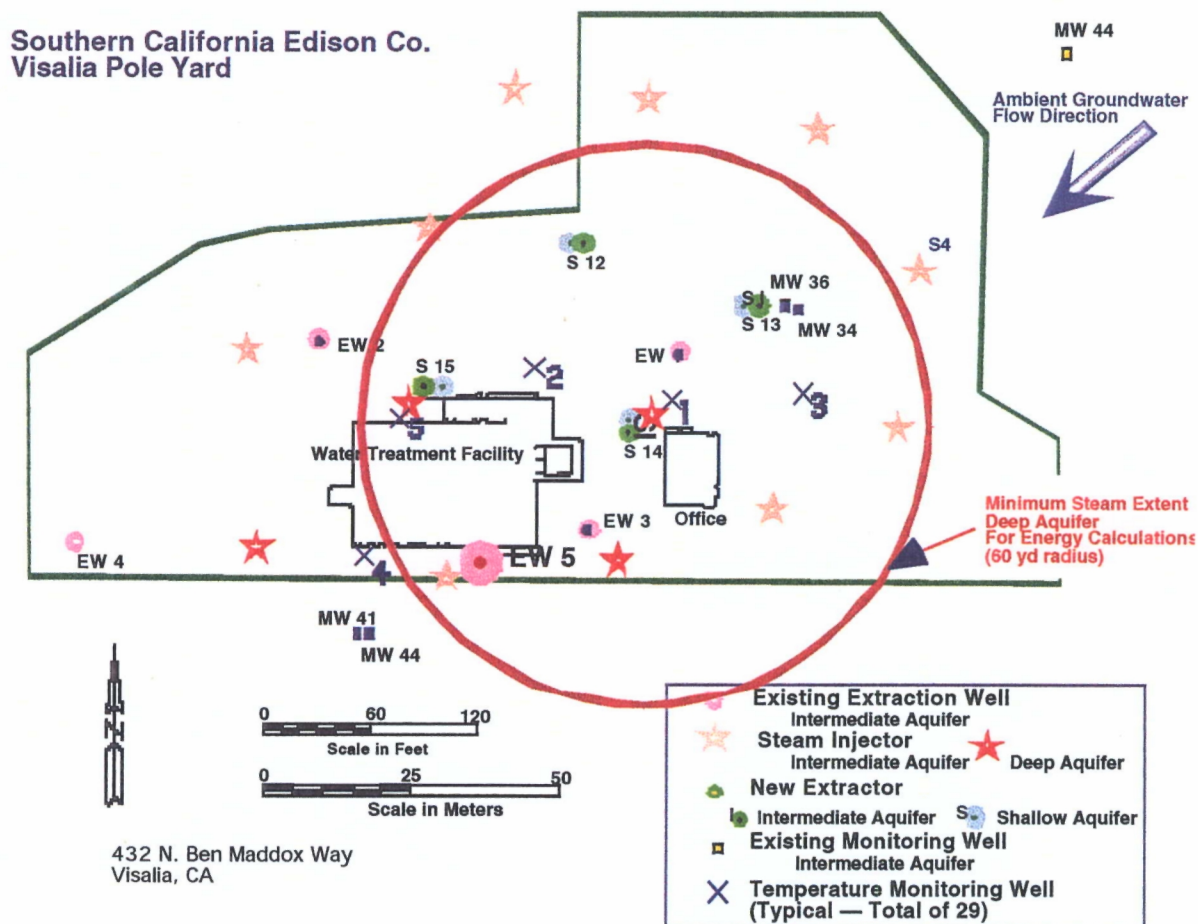
Figure 1. Map of the monitoring and operational wells used for deep-aquifer treatment at Visalia.

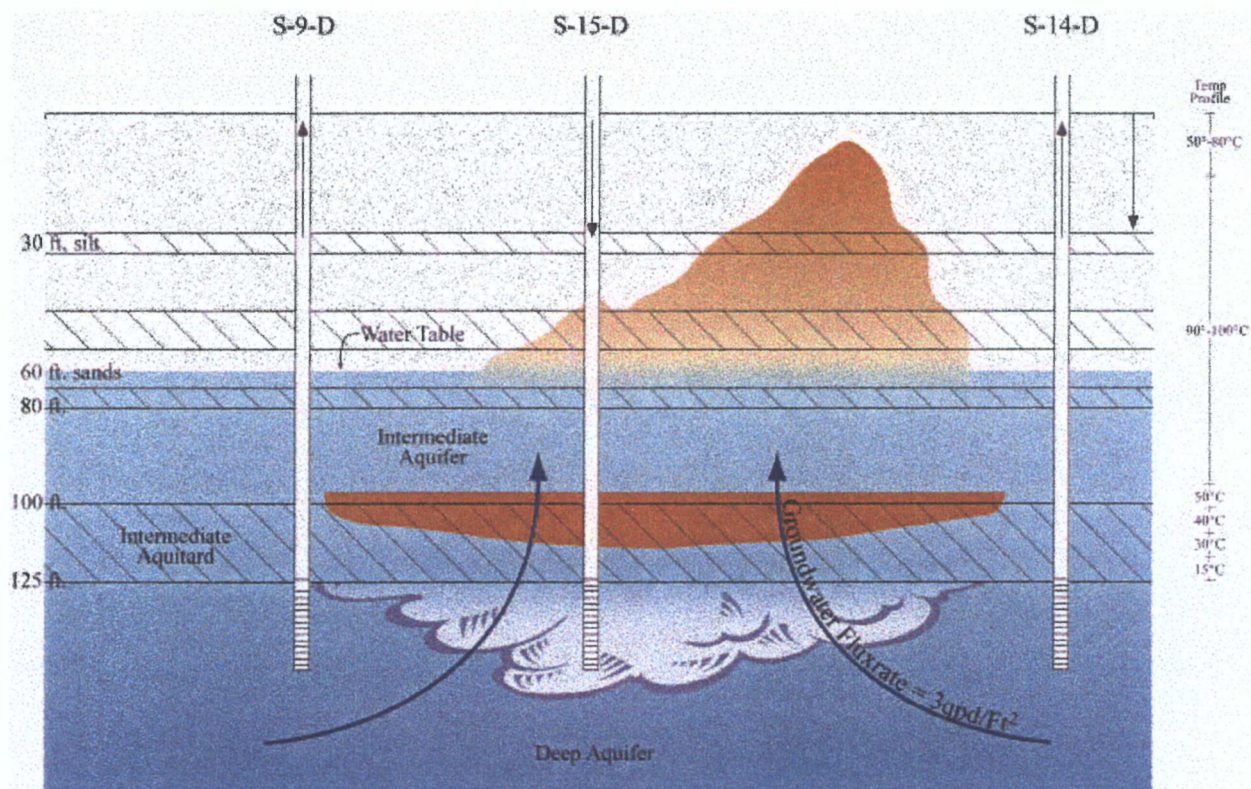
Logs of wells ERT-1 and -2, in particular, show that the boiling-point temperatures had encroached into the aquitard up to depths of 110 ft, approximately 10 ft into the aquitard material. "Huff and puff" operation of a steaming process is intended to ratchet the steam zone into aquitard materials by slightly overpressuring them, then releasing the pressure, which causes any portion of the aquitard above the new boiling point to be disrupted by steam generation. This mechanism was apparently active in the progress of the steam zone upward into the aquitard, and can readily be imagined to have contributed to liquefying bentonite in the well completion and potentially removing it by stoping processes, causing the bentonite to fall out of the conductor casing. Settling and mobilization of fines during previous steaming may have created some void space below the bentonite in the filter pack (around the screen), starting the stoping process.

Figure 2. Edison conceptual drawing of the heating of the deep aquitard by injection of steam into the deep aquifer.
